Home Inspection Report

Inspection Property Address:	2814 Amberleigh, Fayetteville, NC
Client Name(s):	Jill & Daniel Martin
Date of Inspection:	August 13, 2010
Inspector's Name:	Gerald W. Canipe
Inspector's License #:	0237
Inspector's Signature:	<i>Gerald W. Canipe</i>
Associate Inspector's Name:	N/A
Associate's Inspector's License #:	N/A
Associate's Inspector's Signature #:	N/A
Real Estate Agent's Name:	Ella Mandrin

Home Inspection Summary Section

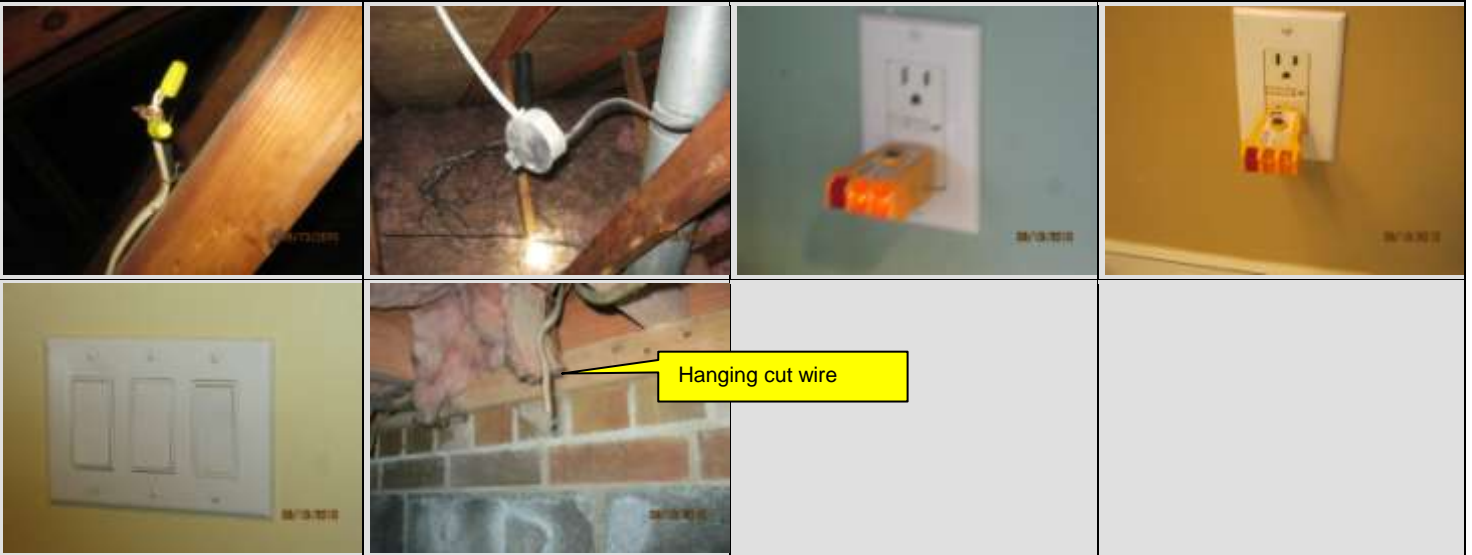
1. Exposed splice noted in the attic over the garage access stairs.
2. The junction box for the attic vent fan is not mounted in the attic and is hanging unsupported.
3. Ground fault outlets in the kitchen and the master bath did not shut the power off when a ground fault was simulated or the test button operated.
4. Unable to determine what two of the three switches operates at the top of the stair landing. The seller may be able to provide further insight. Further investigation by a NC Licensed Electrical Contractor may be desired.
5. A cut wire was noted in the crawl space along the front foundation wall. It is not known what this served or if it has been properly de-energized. Recommend further investigation by a NC Licensed Electrical Contractor.
6. Open junction box observed in the crawl space under the hall bath area with no cover plate poses a safety hazard.

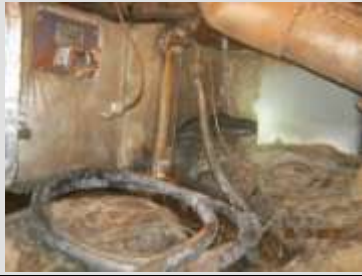
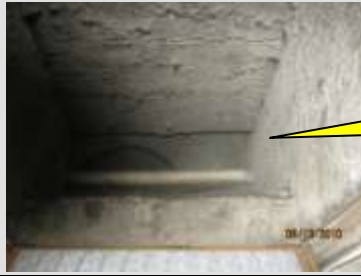
Dust buildup inside return air

Considerable rust and corrosion was observed of the air conditioning evaporator coils in the crawl space. Standing water was noted on the ground under the unit due to no or improper drainage of the condensate and likely failure of the condensate drainage due to rust/corrosion. A temperature drop across the coils was measured at 12 degrees and a range of 15-22 should be expected indicating inadequate cooling. Considerable dust was noted inside the return grill downstairs suggesting the coils of the air handler are likely partially clogged. The ducts are the original and the insulation is coming loose in several areas allowing heat loss/gain. The system is aged beyond it's normal life expectancy and based on the current condition replacement is recommended. Near term failure can be expected.

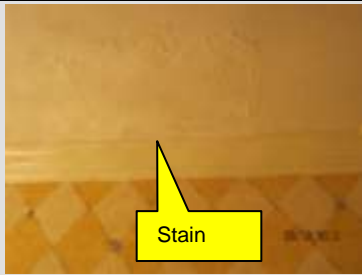
Stain

1. Evidence of repair to the ceiling in the downstairs hall bath just over the entry. A stain has occurred since the repair indicating leakage is still occurring. The area was checked with an electronic moisture and tested positive for high moisture. This is directly under the upstairs bathtub. Recommend further investigation/repair as required.
2. Delamination of the paneling observed in the garage along the front wall nearest the street. Recommend further investigation to determine if any hidden damage may be present inside the wall cavity.

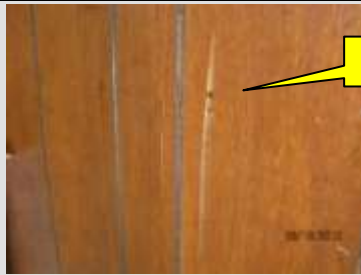
1. Damaged siding noted left of the rear door. Damage will likely continue and can lead to additional damage if not repaired.

Delaminated siding
